Star Motors

Air Suspension - Trouble Shooting Guide

TROUBLE SHOOTING THE AIR SUSPENSION

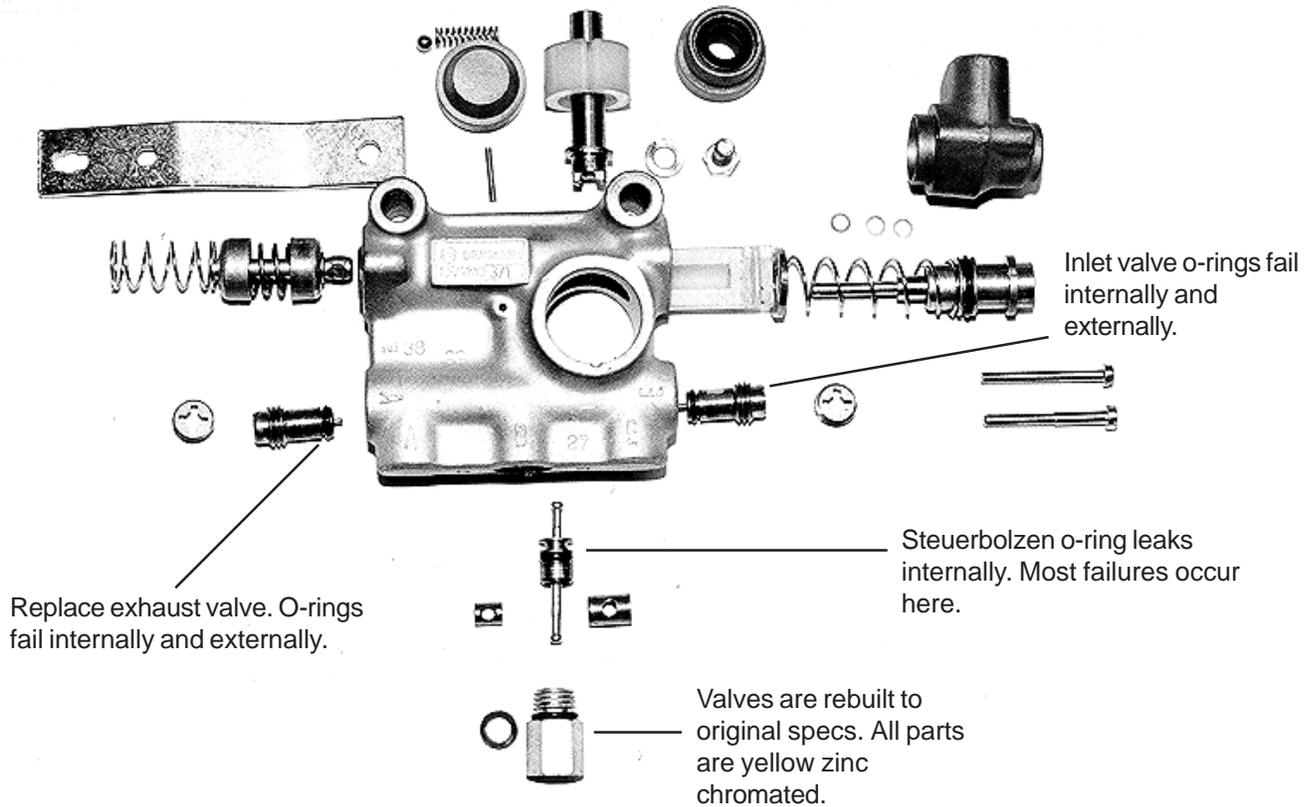
Exploded view of leveling valve.

Most air suspension problems are directly related to the leveling valves and main valve. Generally, most of the other components rarely fail. This trouble-shooting guide is comprehensive in its approach to trouble shooting. Please follow the procedures to diagnose the problems in conjunction with the Mercedes-Benz workshop manuals and figures provided with this guide.
